#### **NBSIR 77-1246**

# Evaluation of the Egress Provisions of the HUD Mobile Home Construction and Safety Standard

May 1977

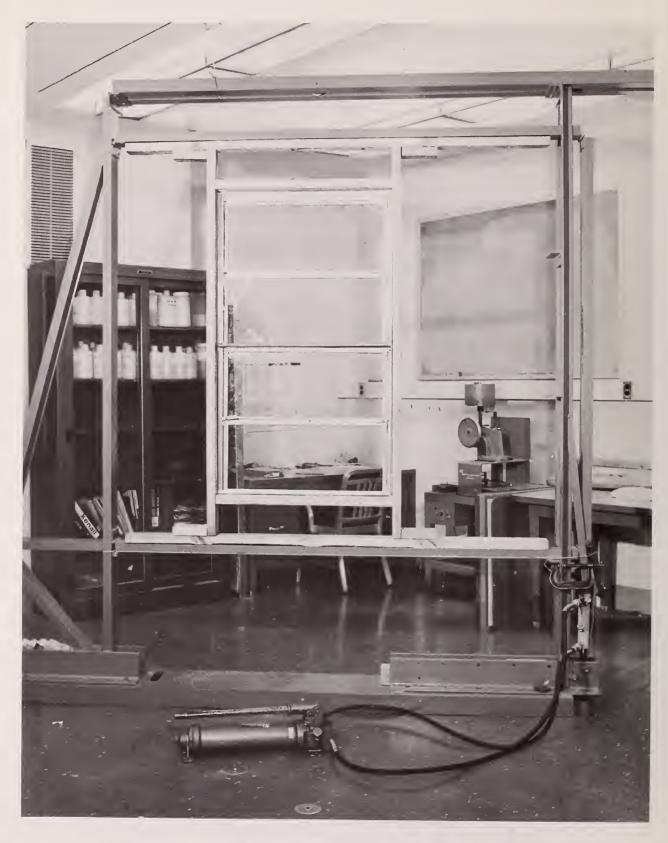
Figure 11. Racking Test. Normal (level) position.

Measurements were made of forces required to unlock and open egress windows after simulated racking loads (frame distortions) were applied. Such loads might occur due to foundation settling or physical displacement of a mobile home following an accident or natural disaster.

Figure 12. Racking Test. Racked position.

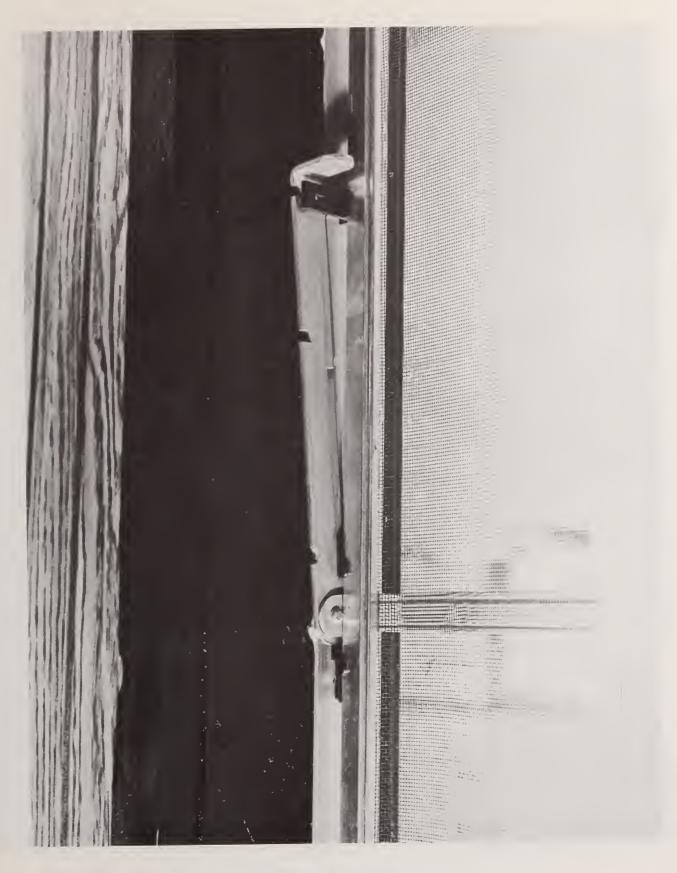
Figure 16. Egress Test. Specimen 1. Detail of egress handle and retaining clip

The force required to remove and lift the storm window exceeds 5 lbs (22.2 N) which appears to be a violation of section 280.404(c)(ii) of the standard.

Figure 17. Egress Test. Specimen 3.
Releasing storm window retaining clip
Releasing one of three clips which retain inside clip-on storm window.
The same storm window frame is used on specimen 4.
